# Special Report 84-10

# Observations during BRIMFROST '83

J.R. Bouzoun, F.D. Haynes, R.E. Perham, K.E. Walker, J.L. Craig and C.M. Collins

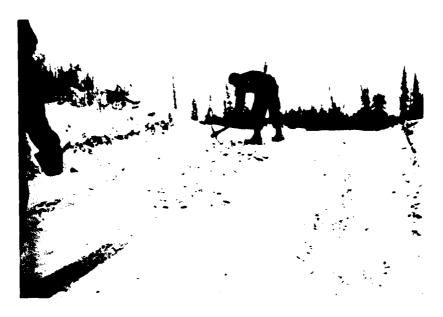
As stated previously, a technical report about these ice bridges is being prepared that will present detailed technical information about them. However, three general observations that may be of assistance during future BRIMFROST exercises will be given here. First, the ice ramps from the stream banks to the surface of some of the ice bridges were extremely steep. As a result it was necessary for the engineer soldiers to attempt to roughen the surface of the ramps by chipping them with a pick to provide traction (Fig. 14). It is suggested that these river banks be carefully cut down in a manner that will not result in any adverse environmental impact on the rivers. Second, in some cases the roadway paralleled the stream and made a right angle turn onto the bridge. These tight turns were difficult for larger vehicles to drive around and, as a result, restricted the flow of traffic and caused bottlenecks in the vicinity of the bridge. In order to

Figure 14. Roughening the surface of the north ramp of ice bridge 2.

alleviate this problem the roadways should be realigned to provide a straighter approach to the crossing sites. Perhaps this could be done as a training project for the engineer units during the summer before the next BRIMFROST exercise. Third, the engineer units at the bridge sites apparently did not have any ice augers. On several occasions engineer soldiers were observed attempting to make holes through the ice with picks and ice chisels. Consideration should be given to issuing ice augers to engineer units operating in arctic or subarctic regions.

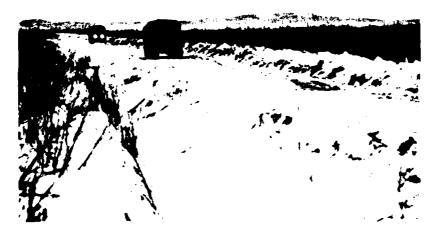
When the snow was cleared, the dozer blade often cut too deeply, removing snow down to bare ground and stripping off the vegetative cover. Not only does the contrast of bare earth and snow make the cleared areas more noticeable, but the stripping of vegetation can cause unnecessary thaw and erosion problems in permafrost terrain. Figure 16 shows areas on a winter trail plowed down to bare earth.

Figure 16. Areas along the winter trail plowed down to bare earth.

The Canadians have used "shoes" on the blades of dozers for years for winter trail construction. The shoes keep the blade from removing the vegetative cover and causing excessive surface disturbance in permafrost areas.

During BRIMFROST '83 a large amount of snow was plowed from the trails and bivouac areas. It is recommended that for future winter training exercises the roads be rolled or dragged in lieu of plowing. If this is not done then shoes should be installed on the dozer blades to prevent excessive surface disturbance in permafrost areas.

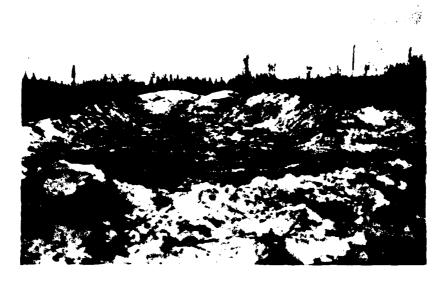
Figure 17. Bivouac area plowed down to bare earth.

Some of the plowed bivouac areas along the winter trail between the Tanana River and Clear Creek appear to be in black spruce terrain that may have ice-rich soil. If so, adverse thawing may occur in these areas this summer. This might have been avoided if the vegetative cover had not been completely stripped away or if the sensitivity of the terrain to disturbance had been recognized and the areas sited elsewhere. Figure 17 shows one of the stripped areas.

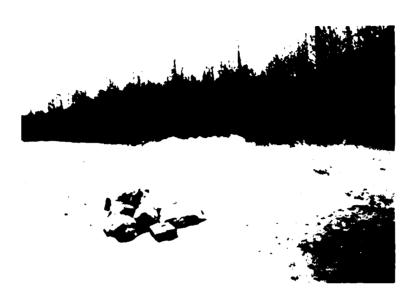
Figure 19. Bags of human and solid waste waiting pickup.

outside (Fig. 19). These bags of human waste, as well as bags of combustible solid waste, such as MCI (meal, combat individual) cartons and boxes, were picked up periodically in vehicles and hauled to the closest incinerator where they were burned.
